Service Bulletin SB-9 Revision A

December 11, 2017

I. SUBJECT

This service bulletin addresses a potential failure of McFarlane Aviation, Inc. part number MC0411257 universal joint. The universal joint is used in various model Cessna aircraft and attaches the control tube to the shaft for control of the flight control surfaces of the aircraft.

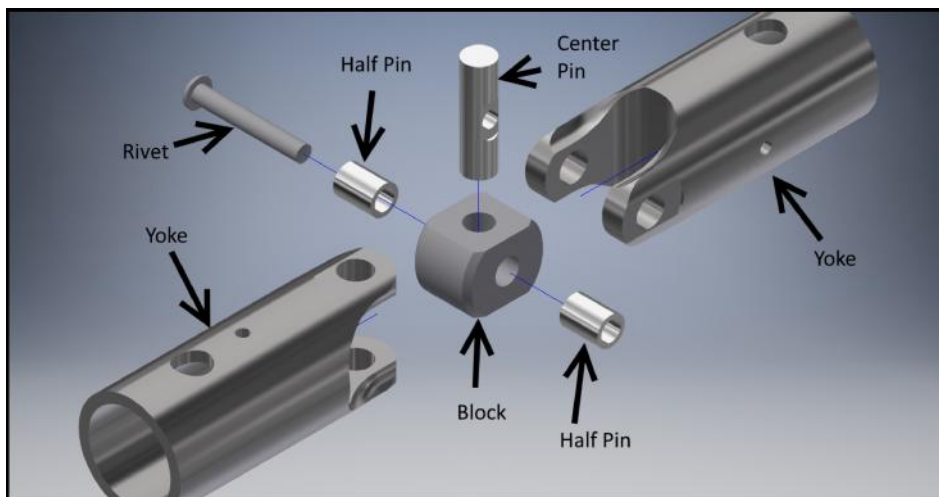
Figure 2

McFarlane Aviation, Inc. was notified that a failure of a part number MC0411257 universal joint had occurred, resulting in a separation of the joint parts.

After review, McFarlane Engineering determined that one or more of the pinned connections became frozen (“locked up”) with possible contributing factors of a) **contact of similar metals (pins and block)**, b) **lack of proper lubrication**, and/or c) **particle contamination of the assembly**. As a result of this lock up and with continued usage, the resultant transfer of force caused galling of the internal parts, failure of the rivet, and, ultimately, separation of the two halves of the joint.

Beginning with production after August of 2016, McFarlane Aviation introduced a nitriding process (in addition to the heat treatment) to the pins and block so as to enhance wear resistance and improve bearing surface tolerance to lack of lubrication and contamination. Additional testing has confirmed that this greatly enhances the ability of the universal joint to resist locking up under adverse conditions. Accordingly, McFarlane Aviation has issued this Service Bulletin with inspection & replacement instructions for joints produced prior to this design change.
