SERVICE

NO. 1194B

Date: April 12, 2012

PERIODIC REPLACEMENT OF NOSE BAGGAGE DOOR COMPONENTS

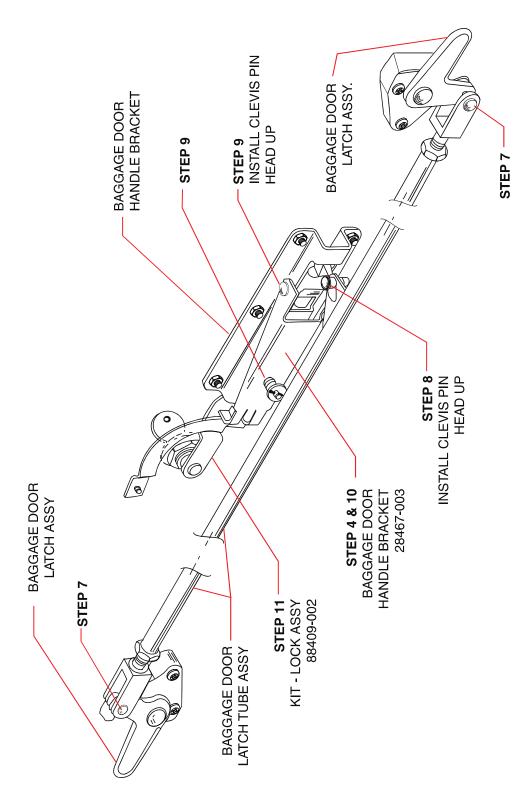
FIGURE 1

INSIDE VIEW OF TYPICAL FORWARD BAGGAGE DOOR LATCH REFER TO TABLES 1, 2, 3 OR 4 FOR MODEL - SPECIFIC HARDWARE

FOR ALL CLEVIS PINS THAT CALL OUT AN AN960 WASHER, PLACE WASHER UNDER COTTER PIN.

- 2. Remove nose baggage door from aircraft per Maintenance Manual instructions. Remove and <u>discard</u> existing clevis pins from the upper forward and aft door hinges.

- 6. Remove and <u>discard</u> springs common to BAGGAGE DOOR LATCH TUBE ASSEMBLY, as applicable. Refer to appropriate Illustrated Parts Catalog and Table 1, 2, or 3 for applicability and location. (Springs not shown in Figure 1.)
- 7. Remove and <u>discard</u> existing clevis pins that join the BAGGAGE DOOR LATCH TUBE ASSEMBLY to the forward and aft BAGGAGE DOOR LATCH ASSEMBLY.
- 8. Remove and <u>discard</u> existing clevis pin common to the BAGGAGE DOOR LATCH TUBE ASSEMBLY and the FORWARD BAGGAGE DOOR HANDLE.

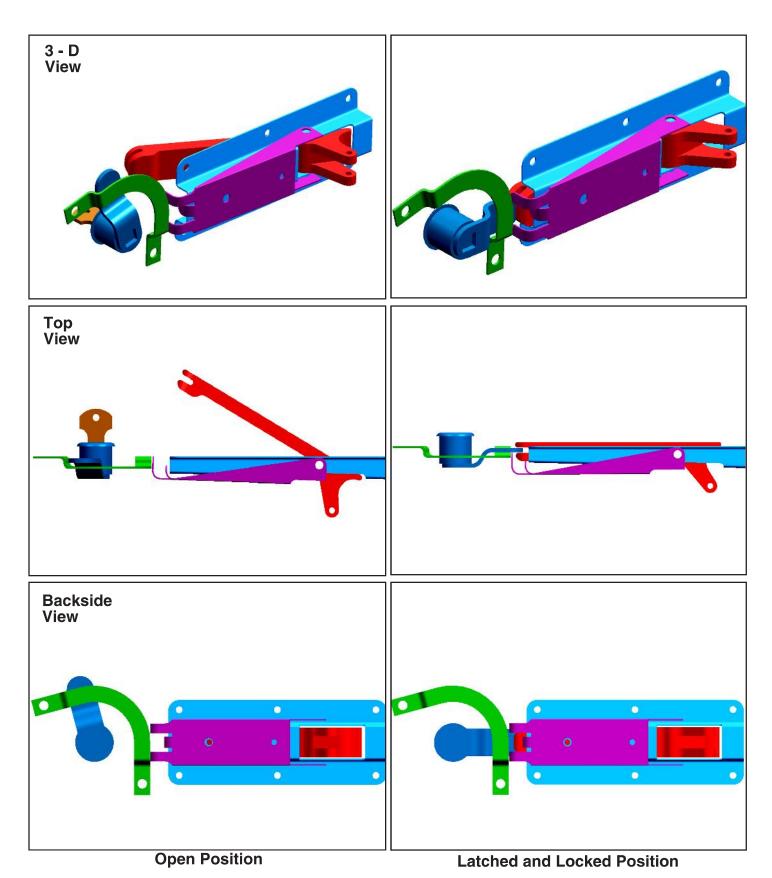
Figure 3
Door Latch Mechanism

The 28467-003 Bracket is hinged at the forward end with a clevis pin common to the Door Handle and the 30580-000 Baggage Door Handle Bracket, and features three right-angle prongs at the aft (key lock) end. In the locked position (i.e., prepared for flight), the middle prong exerts contact pressure against the Door Handle (due to compression force from the coil spring which is mounted on the back of the 28467-003 Bracket), holding the adjacent upper and lower prongs inboard, clear from contact with the locking cam.

Normal opening sequence is as follows: A key is inserted into the key lock and turned, rotating the locking cam out of the slot in the Door Handle. When the key is rotated beyond approximately 40 degrees from the locked position, the coil spring acts to push the aft end of both the 28467-003 Bracket and the Door Handle outboard (open), by a distance of approximately one quarter (1/4) inch. With the 28467-003 Bracket in this outboard position, the upper prong now blocks the return path of the locking cam, preventing the locking cam from rotating back into the locked position unless the handle is pushed back into the fully latched position (thereby preventing the condition described in SB604A, noted above).

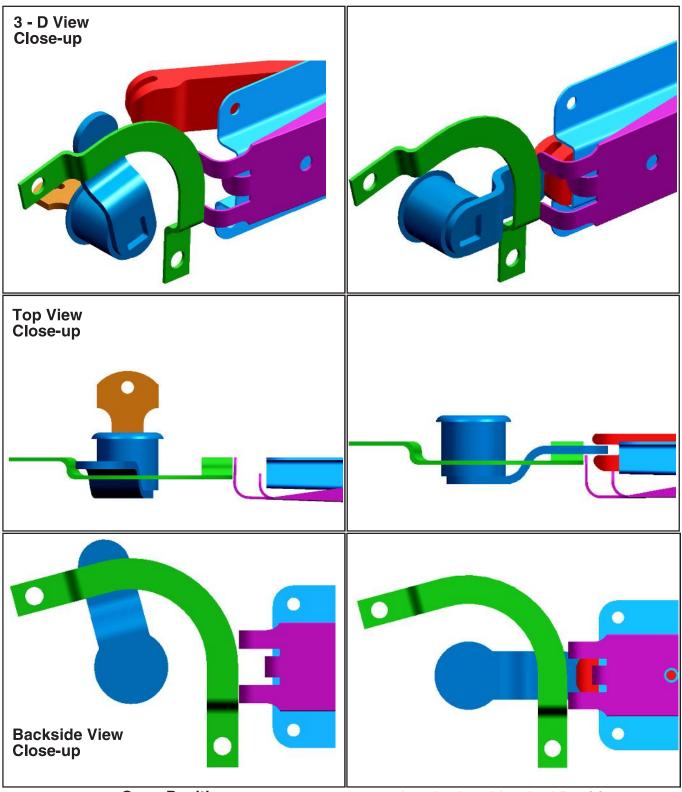
Figure 4 Door Latch Mechanism Close-up View

As part of the normal door closing sequence, the aft end (nearest the key lock) of the Door Handle is pressed flush with the surface of the outer door. This action causes contact pressure between the Door Handle and the middle prong of the 28467-003 Baggage Door Handle Bracket. Both parts rotate together on a common hinge line, compressing the spring, and moving the upper prong inboard, out of the path of the locking cam.

With the Door Handle held flush as described above, the key may then be turned to the locked position, engaging the locking cam into the slot in the Door Handle. With the locking cam in the locked position, removal of the key prevents rotation of the locking cam, which in turn prevents the door handle from opening.

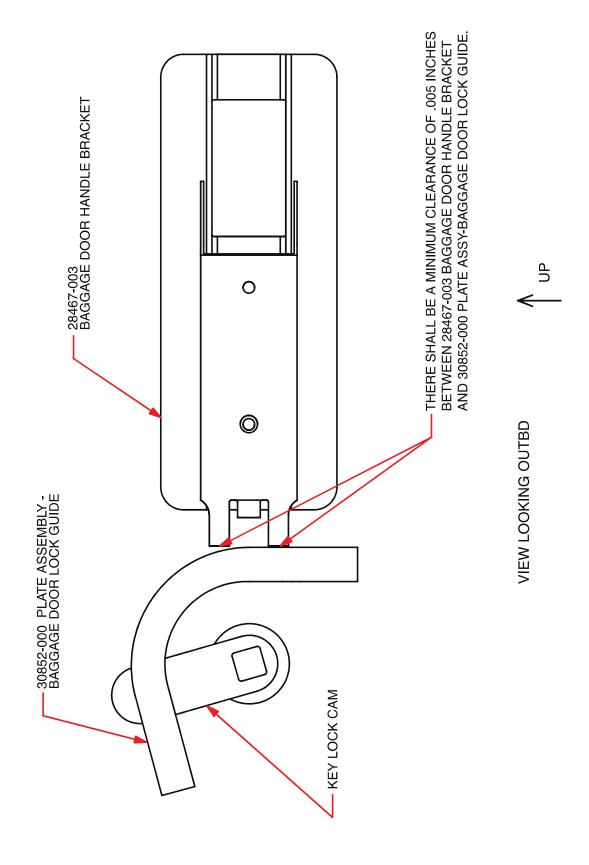
Figure 5
CORRECT INSTALLATION SHOWING POSITIVE
CLEARANCE BETWEEN 28467-003 & 30852-000

- 5. With the 28467-003 BAGGAGE DOOR HANDLE BRACKET installed, verify that a .005 inch minimum gap exists between this part and the 30852-000 PLATE ASSEMBLY BAGGAGE DOOR LOCK GUIDE, as shown in Figure 5. This positive clearance must exist during the entire latching and locking sequence.
 - If these two parts maintain a clearance of .005 inches or more during the entire door latching and locking sequence, no rework is required.
 - If these two parts cannot maintain a clearance of .005 inches or more during the entire door latching and locking sequence as currently installed, or if contact occurs between these parts, relocate the factory-installed 30852-000 PLATE ASSEMBLY BAGGAGE DOOR LOCK GUIDE as follows:

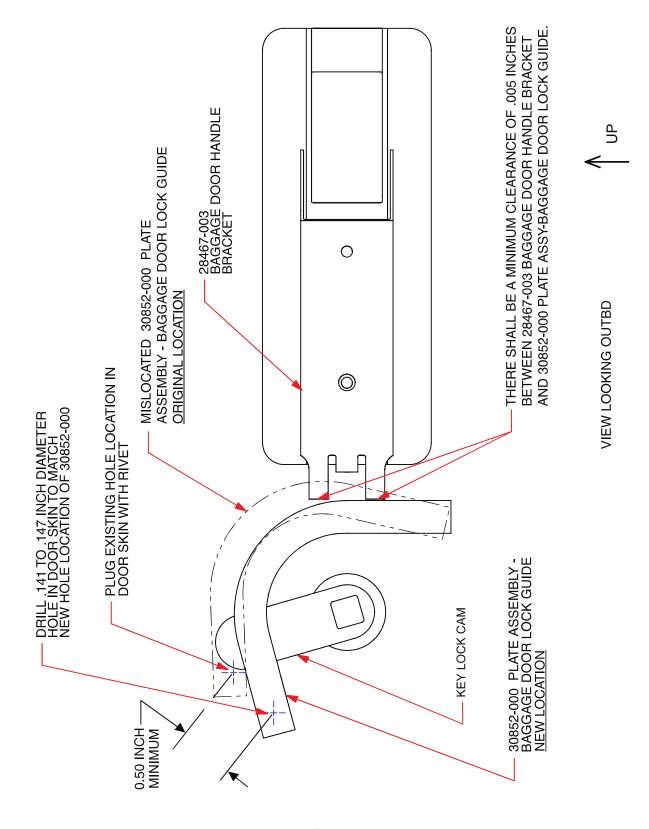
FIGURE 6

RELOCATION OF 30852-000, IF
REQUIRED TO ACHIEVE CLEARANCE
FROM 28467-003

Remove upper screw, and loosen lower screw. Rotate the 30852-000 PLATE ASSEMBLY – BAGGAGE DOOR LOCK GUIDE as needed to achieve clearance, as shown in figure 6. With a positive clearance of at least .005 inches established, verify proper operation of latching and locking mechanism. Mark the door skin with the new location of the upper threaded insert in the 30852-000 PLATE ASSEMBLY – BAGGAGE DOOR LOCK GUIDE. Verify that the spacing between this new proposed fastener location and the original fastener location is at least .50 inches. Drill a .141 to .147 inch diameter hole in the door skin, to match the new location of the upper threaded insert in the 30852-000 PLATE ASSEMBLY – BAGGAGE DOOR LOCK GUIDE. Plug the original open hole with a driven rivet of suitable size, MS20470AD or equivalent, with manufactured head placed on the outboard side of the door. Tighten both screws common to the 30852-000 PLATE ASSEMBLY – BAGGAGE DOOR LOCK GUIDE. If needed, it is permissible to remove .05 inches of material from the 30852-000 PLATE ASSEMBLY – BAGGAGE DOOR LOCK GUIDE to achieve the required operating clearance, provided that the reworked edge is smooth, free of scratches or burrs, blended into adjacent surfaces, and painted with suitable primer.
