Tail Cone Reinforcement Kit: Installation Instructions for Cessna 180, Early 182, and 185 Aircraft

Document Number: ST02171AK-A INSTALL Revision: E 4/3/2024

FAA Project Number: SA02522AK

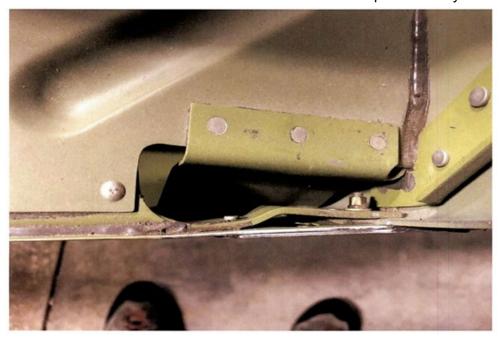
The tail-cone reinforcement angles (P/N 0712207-1 and -2) tend to crack at the rear stabilizer attach pivot. Figure 2 and Figure 3 show the area of concern, and an example of where cracks have been found in service. It is understood that all the cracks form at the same spot with very similar propagation.

Figure 2: Tail Cone Reinforcement Angle (LH shown, RH opposite)

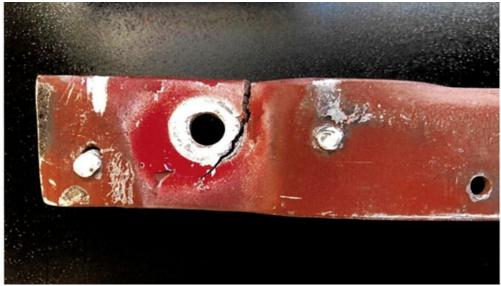
Figure 3: Typical crack in the Tail Cone Reinforcement Angle (LH shown)

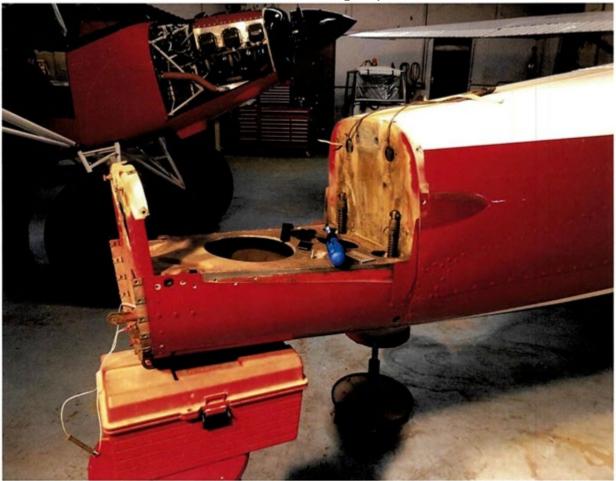
Note: Figure 6 shows the tailwheel and stinger removed. Removal of the tailwheel and stinger are not required for installation of the tail cone reinforcement angle splice

Figure 6: Prepared Aircraft

- Prepare the aircraft for maintenance. Make sure the aircraft is electrically grounded.
 Make sure that all the switches are in the OFF position. Disconnect electrical power
 from the aircraft.
- 2. Remove the tail cone and all fin and horizontal stabilizer tail fairings as needed.
- 3. Disconnect the rudder control cables at the rudder bell crank.
- 4. Disconnect the elevator bell crank tube from the elevator pylon.
- Remove attaching hardware for the vertical stabilizer and rudder. Remove the vertical stabilizer and rudder.
- 6. Disconnect attaching hardware for the horizontal stabilizer and elevators. Remove the horizontal stabilizer and elevators. The aircraft tail should now look like Figure 6.

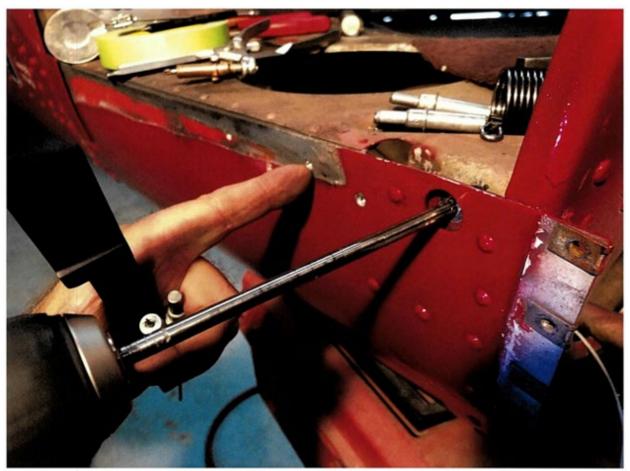
Figure 7: Reaming Rear Pivot Holes

1. Using the supplied ¼" diameter reamer, ream both the outer and inner LH horizontal rear pivot holes as shown in Figure 7.

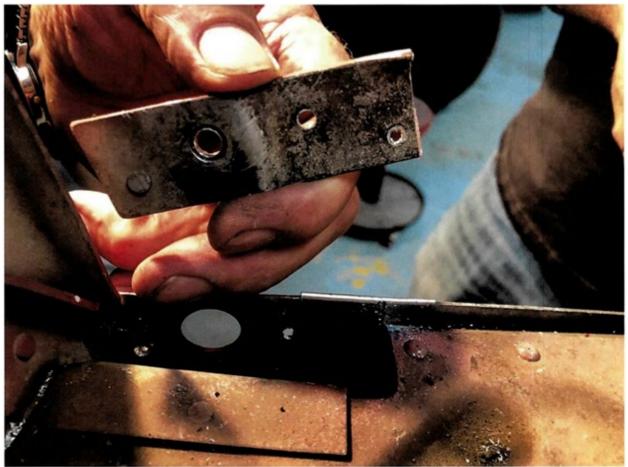
Figure 12: Remove cut off portion of reinforcement angle

6. Remove the cut portion of the tail cone reinforcement angle as shown in Figure 12.

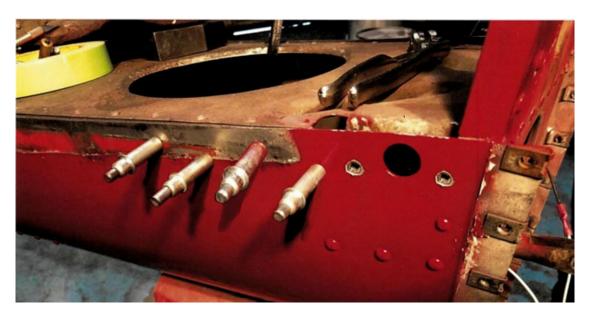
Figure 18: Cleco Reinforcement Angle Splice onto aircraft

6. After drilling the holes, use clecos to secure the reinforcement splice part to the aircraft as shown in Figure 18.

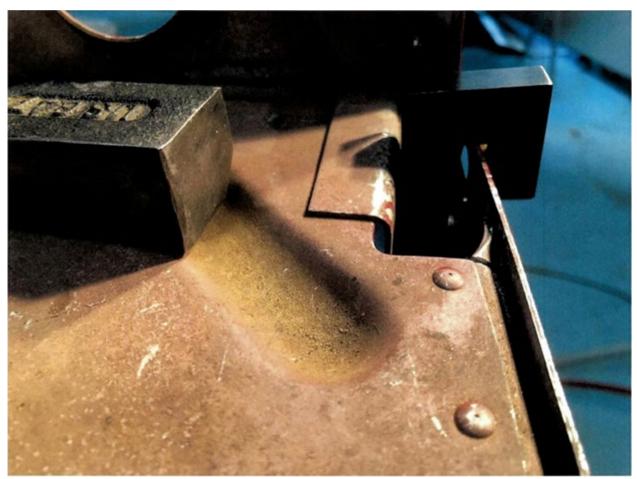
Figure 29: Insert drill guide assembly

17. Now it is time to drill a pilot hole in the tail cone reinforcement angle splice for the horizontal stabilizer rear pivot with the supplied drill guide assembly. Insert the drill guide assembly as shown in Figure 29.

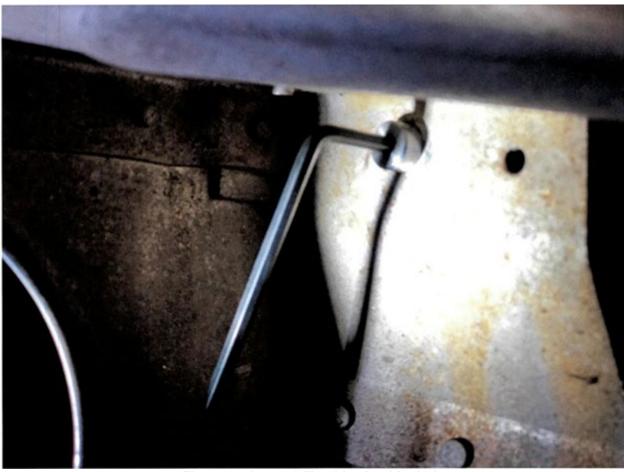
Figure 30: Insert drill guide shoulder bolt

18. Using the supplied hex key and box wrench, insert the drill guide shoulder bolt into the drill guide assembly from inside the tail cone through the existing horizontal stabilizer pivot hole as shown in Figure 30.

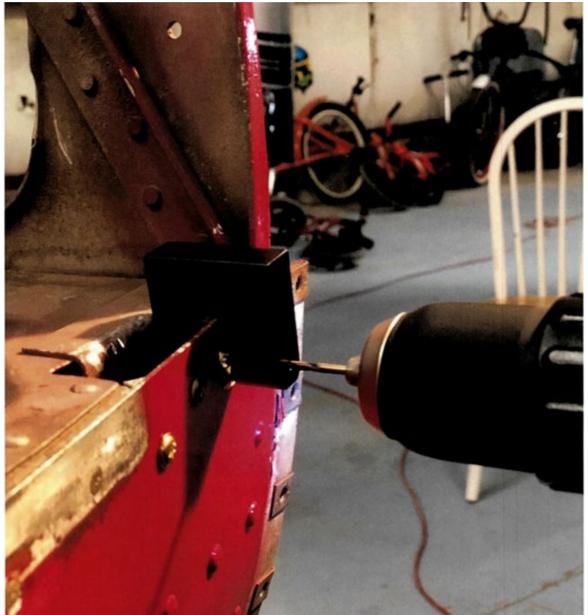
Figure 31: Drill pilot hole through reinforcement splice

19. Using a #40 drill bit, drill a pilot hole through the tail cone reinforcement angle splice using the installed drill guide fixture as shown in Figure 31.

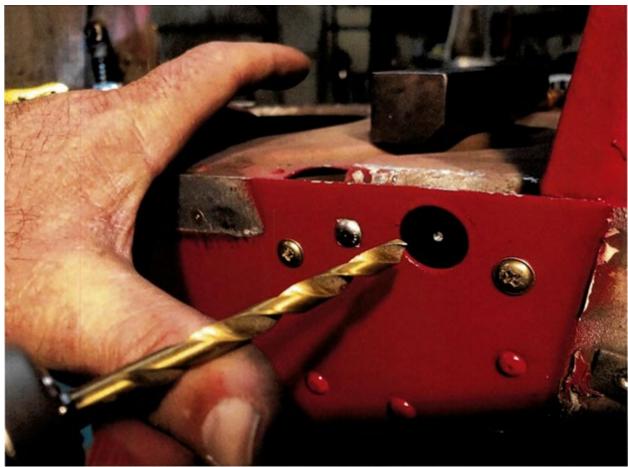
Figure 32: Open up pilot hole

20. Remove the drill guide fixture and open up the pilot hole with the supplied 15/64" diameter drill bit as shown in Figure 32. Align the drill bit to be perpendicular to the inner bracket.

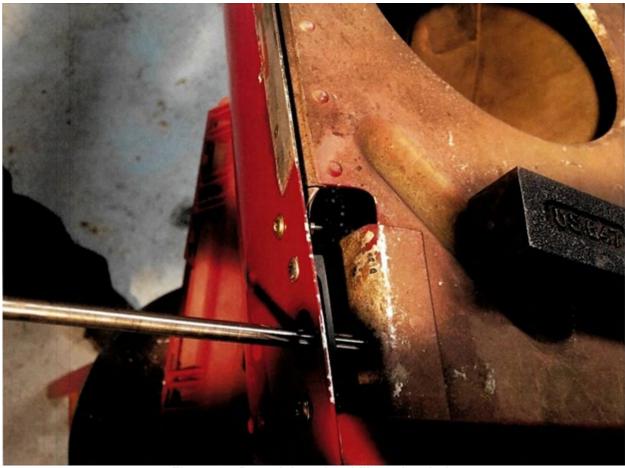
Figure 34: Ream inboard stabilizer pivot hole

22. Using the ¼" diameter reamer continue to ream through the inboard horizontal stabilizer pivot hole as shown in Figure 34.

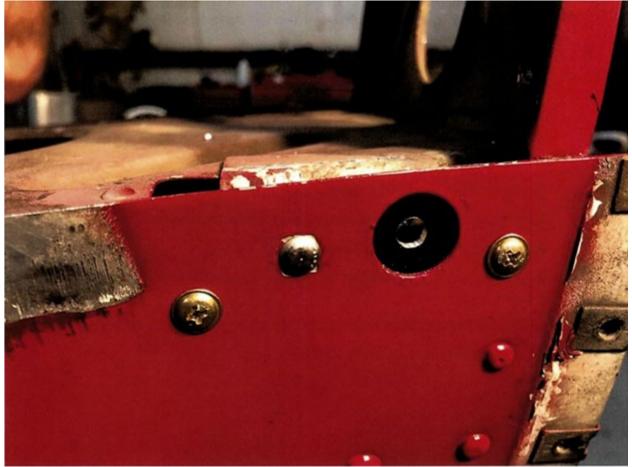
Figure 35: View of finished Reinforcement Splice Installation

23. Your aircraft should now look like Figure 35.
